INITIAL SITE INVESTIGATION REPORT

VILLE GARAGE
67 Broad Street
Lyndonville, Vermont

30 December, 1997

MARIN Project #V97-091

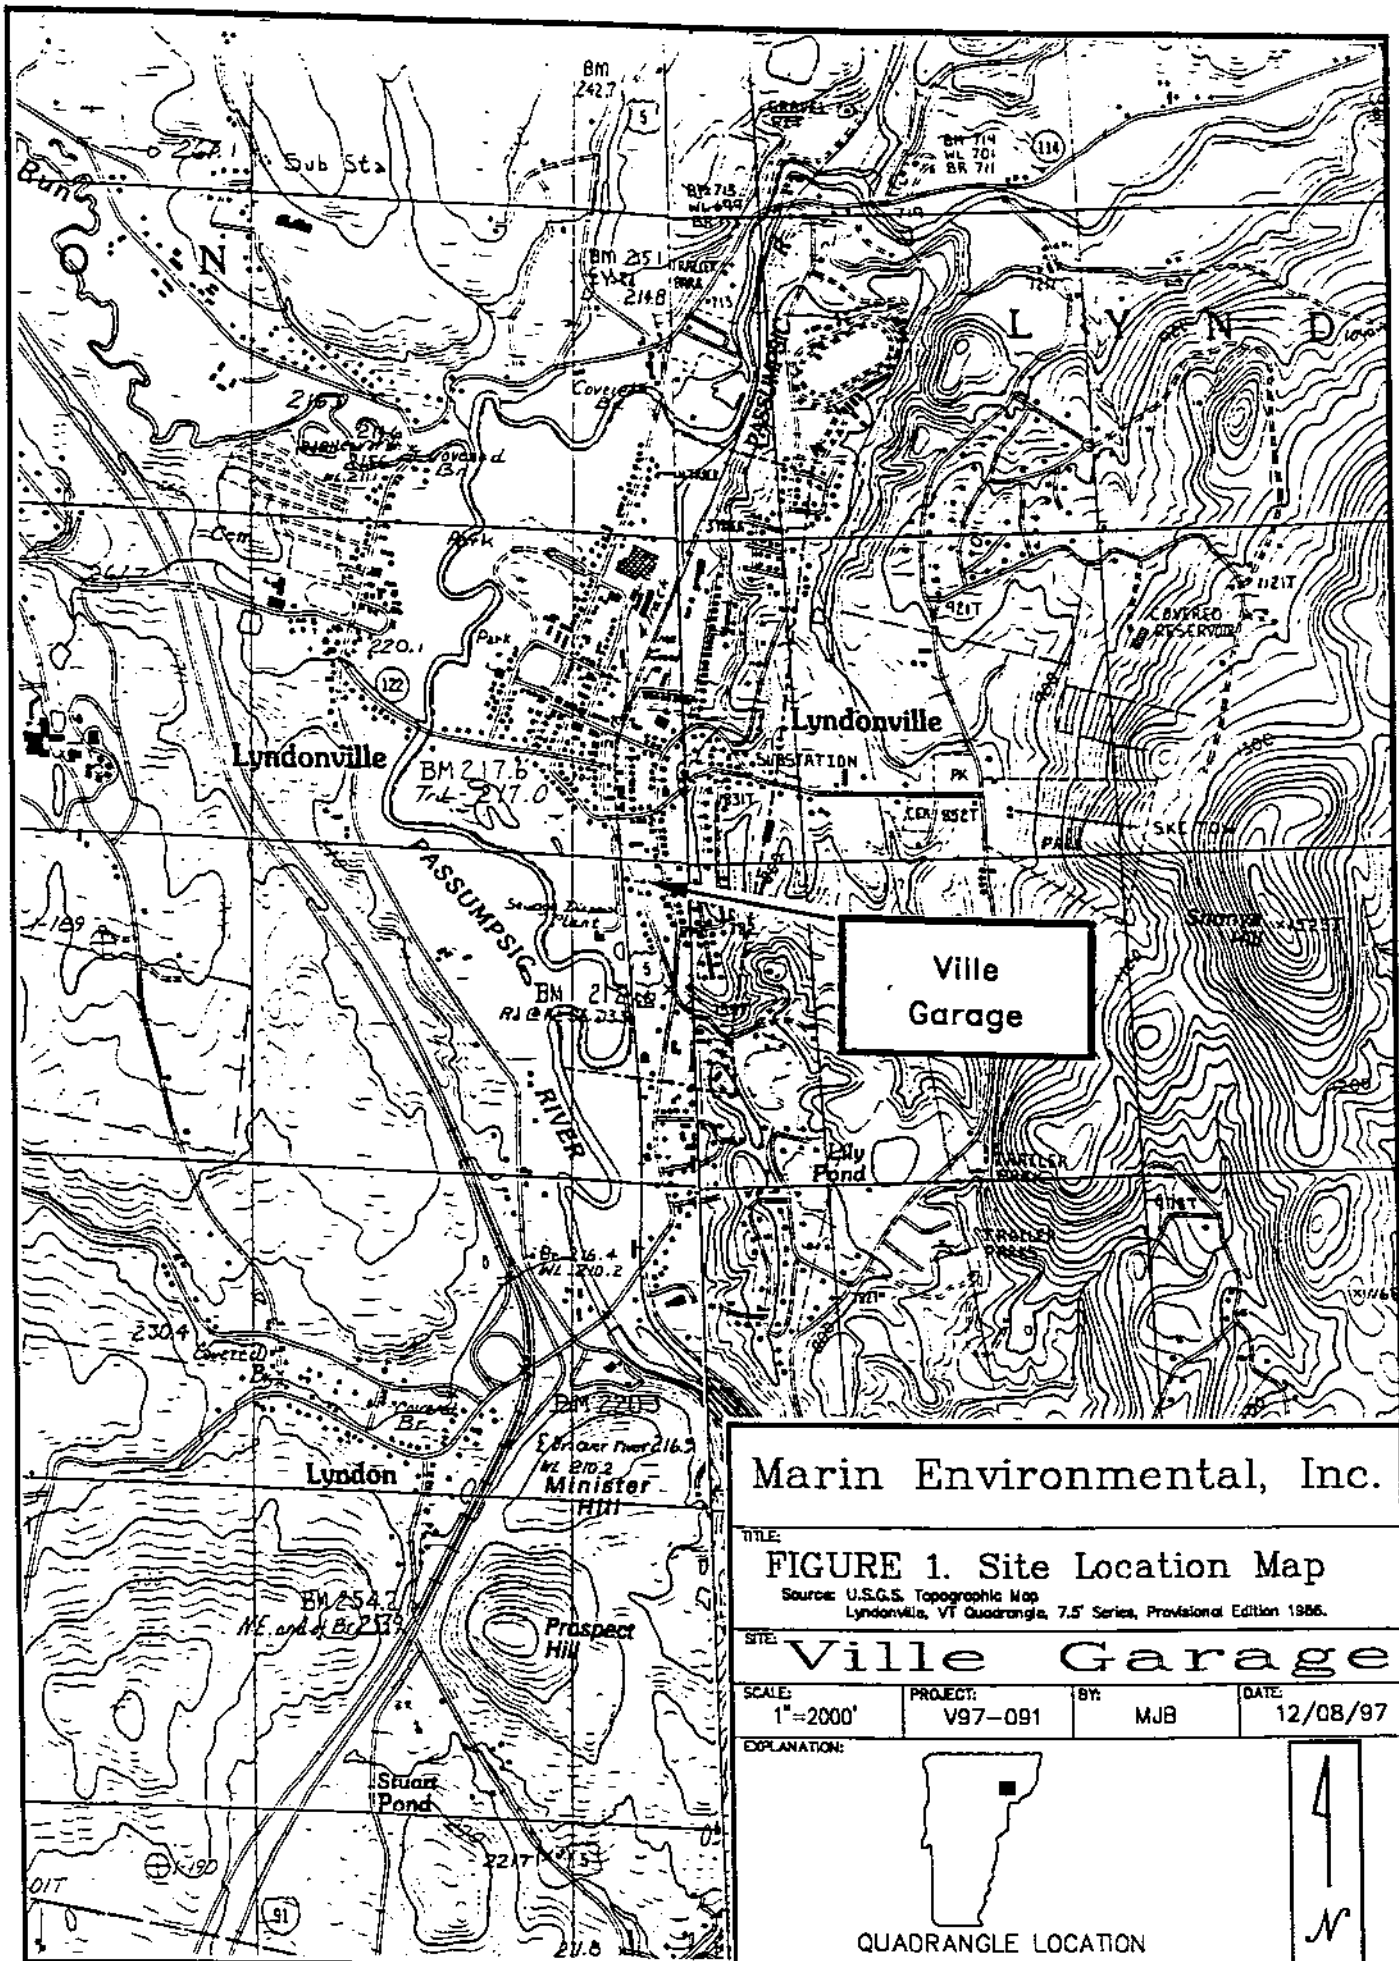
On 22 September 1997, the three 1980 era gasoline USTs were removed by Fred's Plumbing and Heating with the assistance of Gosselin's Excavating, both of Derby, Vermont; a 10,000-gallon tank (UST #1), a 6,000-gallon tank (UST #2), and a 4,000-gallon tank (UST #3). A MARIN field scientist performed an UST closure assessment on the day of removal, and submitted a report, dated 29 September 1997, to Mr. Williams and the VT DEC. The approximate locations of the USTs removed on 22 September 1997 are shown in Figure 2 in Appendix A.

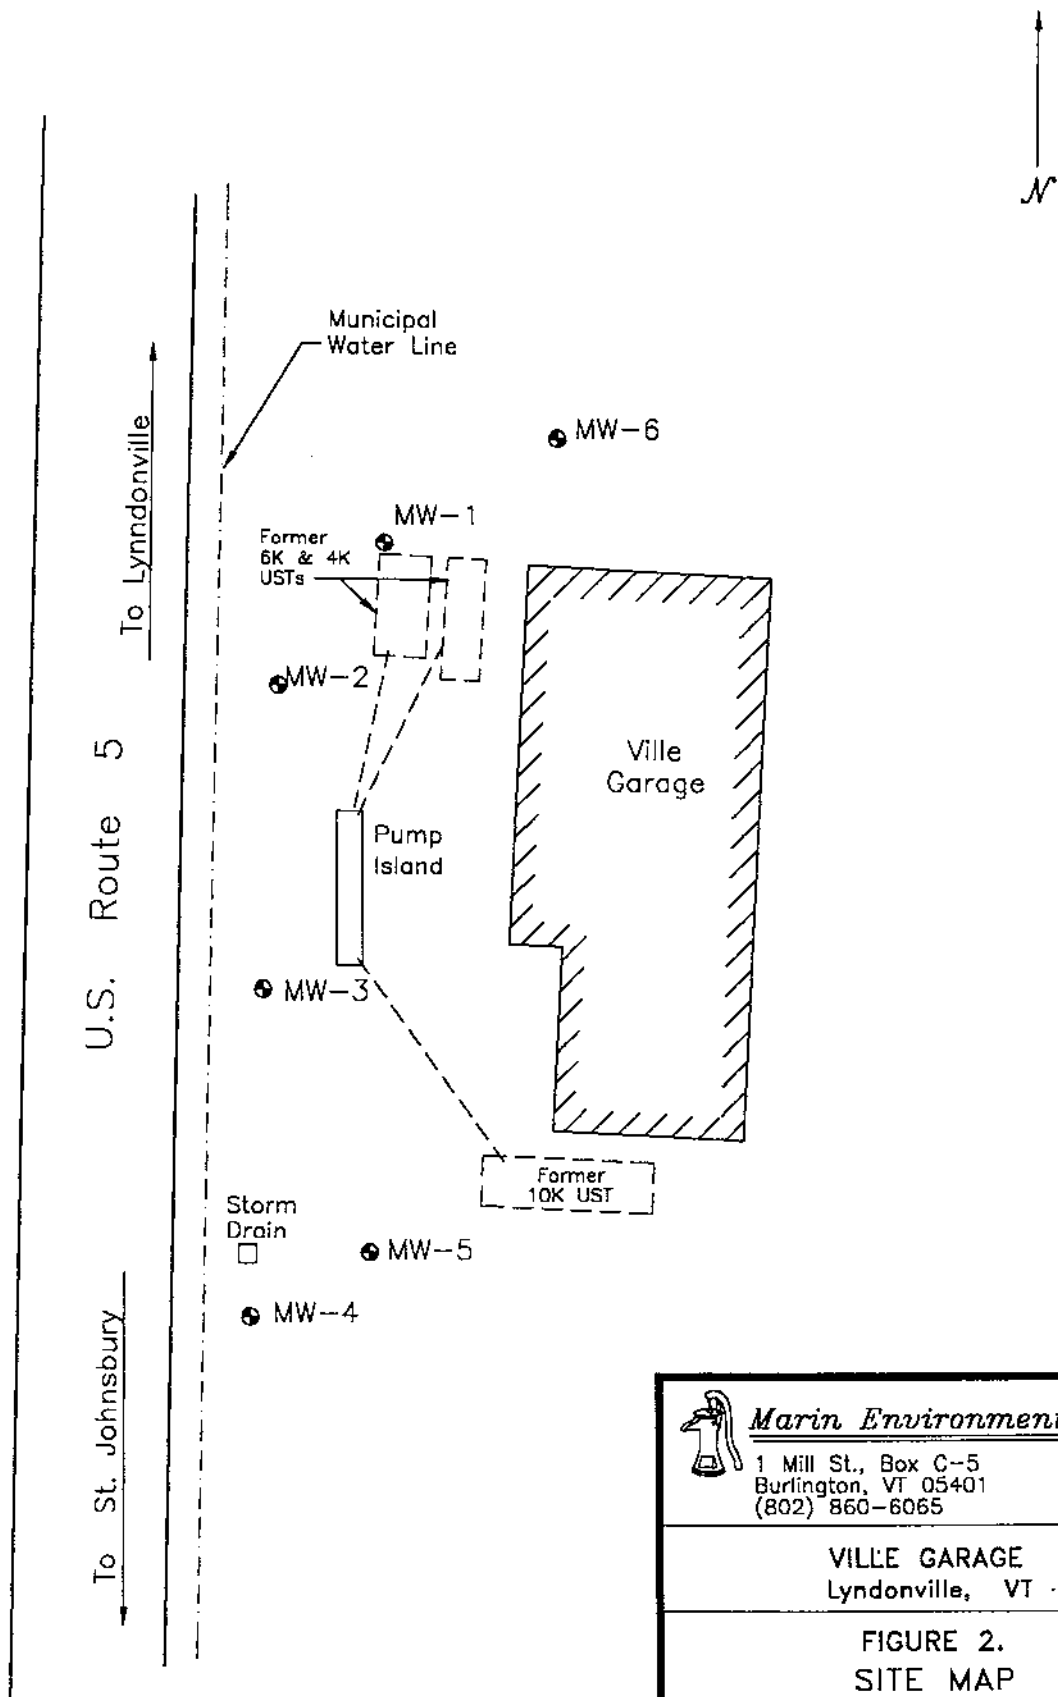
FIGURE 2.

In order to evaluate the degree of contamination in the three possible on-site source areas, monitoring wells were installed at both of the former UST locations and adjacent to the pump island. MW-1 was installed in the UST #2 and #3 excavation, MW-3 was installed in the presumed downgradient direction from the pump island, and MW-5 was installed in the UST #1 excavation. Two other monitoring wells were installed downgradient of the UST excavations (MW-2 and MW-4), and one monitoring well was installed upgradient of the site (MW-6). Approximate well locations are shown on Figure 2 in Appendix A; well construction details are presented in Appendix C.

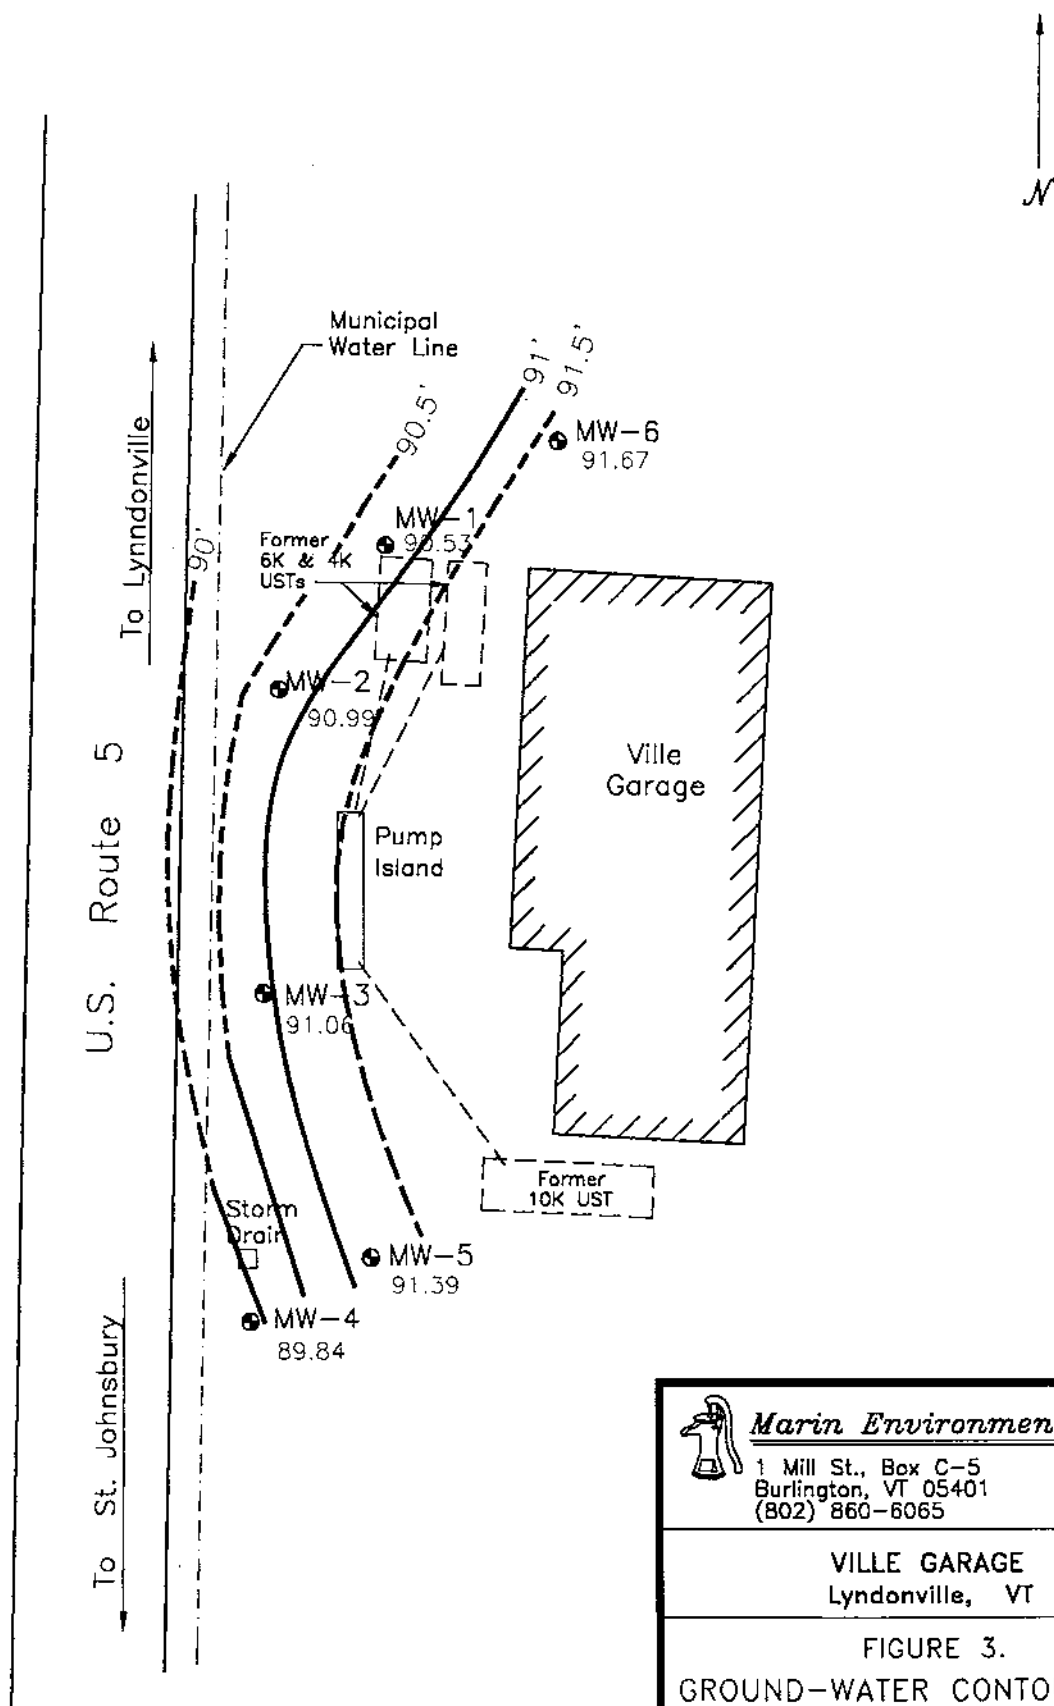
FIGURE 3.
GROUND-WATER CONTOUR MAP
MONITORING DATE: 26 OCTOBER 1997

Ground water in the unconfined surficial aquifer directly beneath the site appears to be flowing in an westerly direction, as originally presumed. The average gradient of the local ground-water table on 26 October 1997 was approximately six percent. Average flow velocities in the ground water are estimated to be on the order of 0.4 to 21 feet per day. Water-level measurements and elevation calculations are presented in Table 1. The ground-water contour map (Figure 3, Appendix A) was prepared using this data.

The depth to water varied from 6.23 feet (MW-5) to 8.36 feet (MW-4) below top-of-casing. No free-phase petroleum was observed in any of the wells; however, each well, except MW-6, exhibited a strong petroleum odor. Static water-table elevations were computed for each monitoring well by subtracting the measured depth-to-water readings

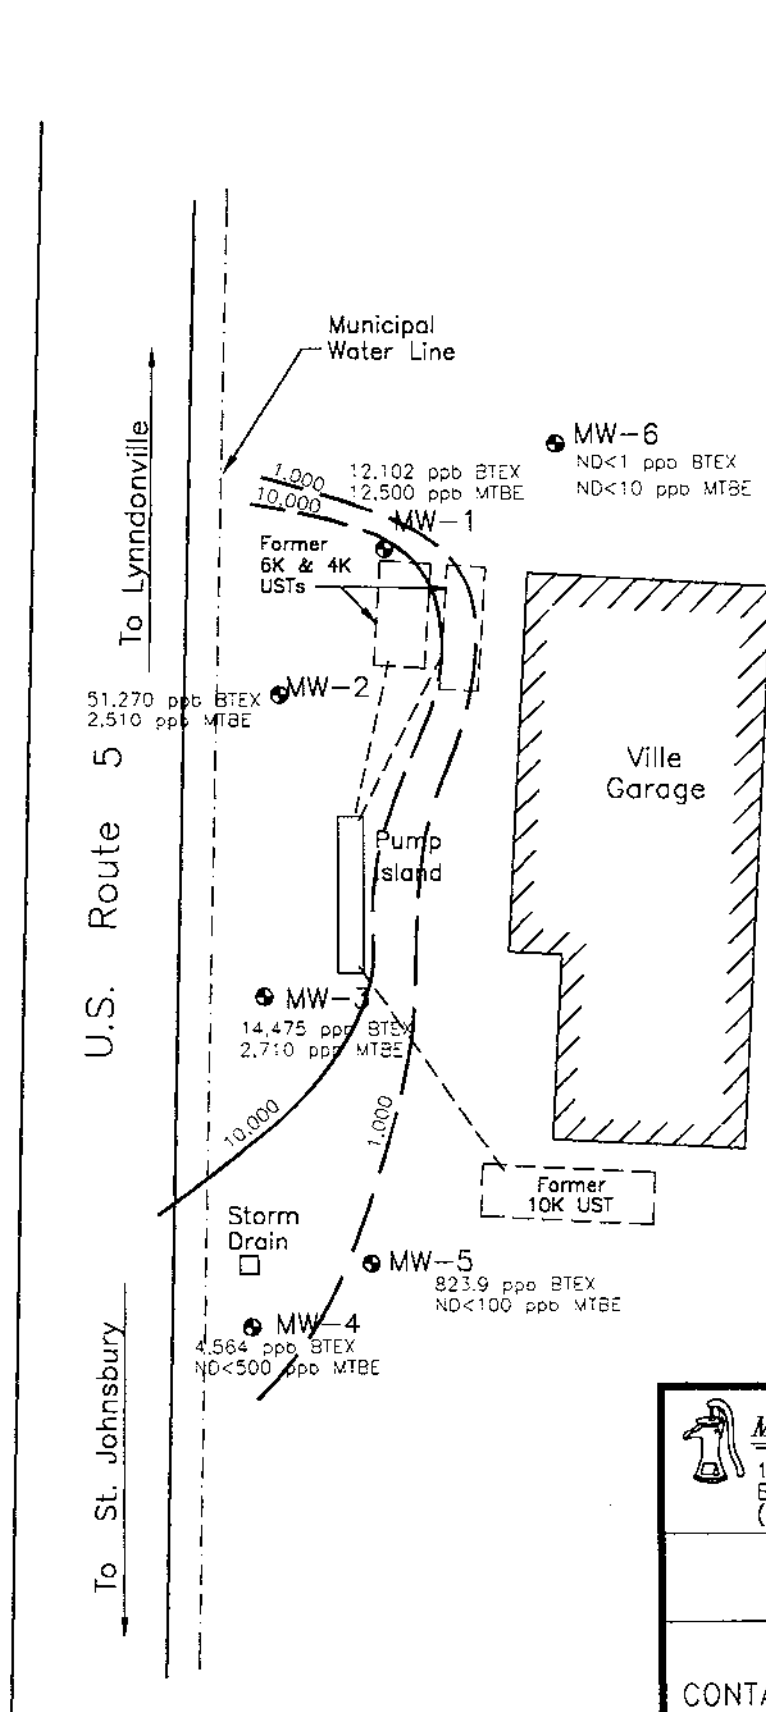
FIGURE 4.
CONTAMINANT DISTRIBUTION MAP
MONITORING DATE: 26 OCTOBER 1997

Ground-water analytical results indicate that ground water in the shallow soil aquifer beneath the site is contaminated with gasoline compounds, and that the contaminated ground-water is migrating off-site toward the west and southwest. The nature and distribution of petroleum contamination at the site suggest that the principal source areas are the former gasoline pump island and former USTs #2 and #3, but that gasoline releases have also occurred in the vicinity of former UST #1. Analytical results are summarized in Table 2, a contaminant distribution map is presented as Figure 4, and laboratory report forms are included in Appendix D.

One or more of the Vermont Ground-Water Enforcement Standards (VGESs)¹ for volatile petroleum compounds were exceeded in each monitoring well, except MW-6. Exceedances of the VGESs are highlighted on Table 2.

Methyl-tertiary butyl ether (MTBE), an octane-boosting gasoline additive, was detected above the VGES in MW-1, MW-2, and MW-3, at concentrations ranging from 2,510 to 12,500 ppb. A replacement for tetra-ethyl lead, MTBE has been in widespread use in gasoline since about 1980. The apparent absence of MTBE in MW-4 and MW-5, located in the vicinity of UST #1, suggests the contamination in that area of the site may be associated with an older release; however, the detection limits for the MW-4 and MW-5 samples were high (500 and 100 ppb, respectively) due to sample dilution for analysis.

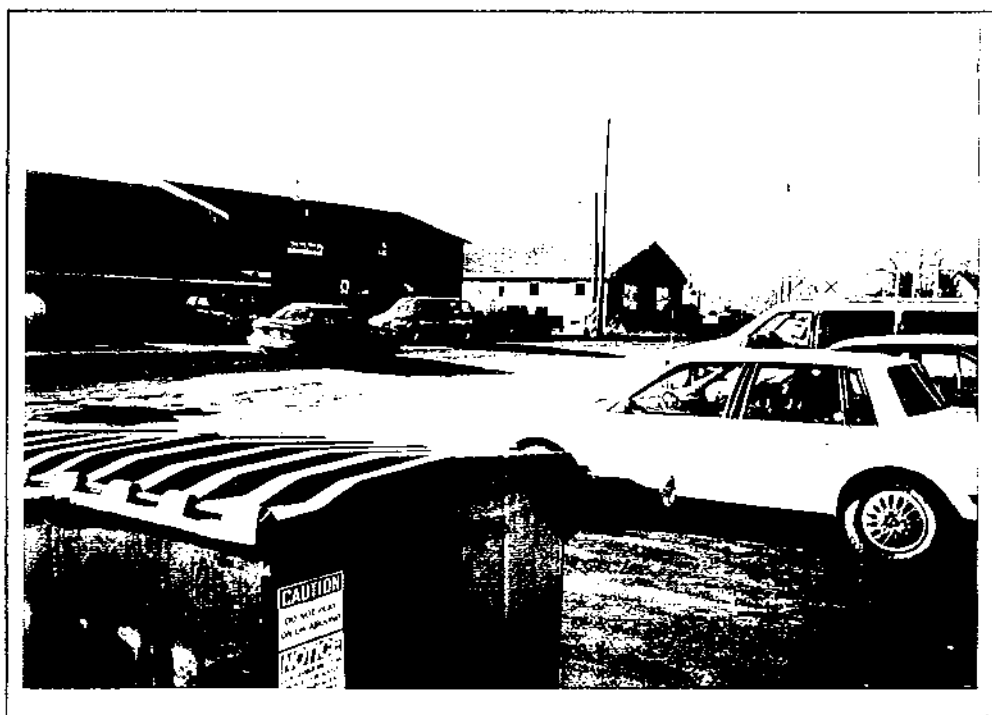
VIEW TOWARD NORTHEAST
(The Feed Exchange)

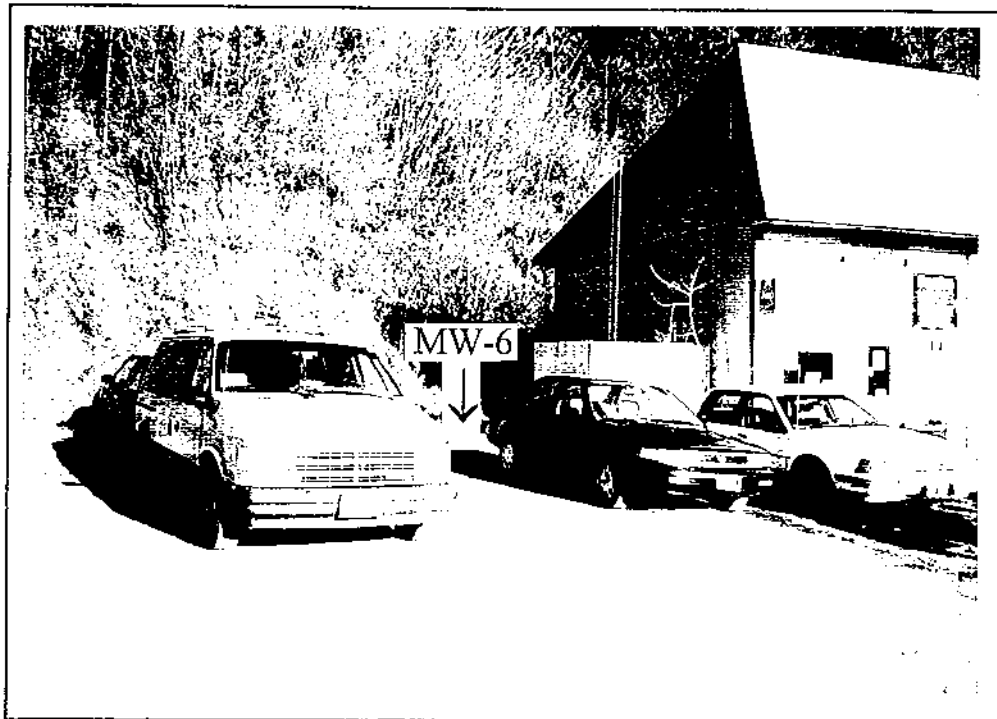
VIEW TOWARD SOUTHEAST
(MW-6 Behind Black Sedan)

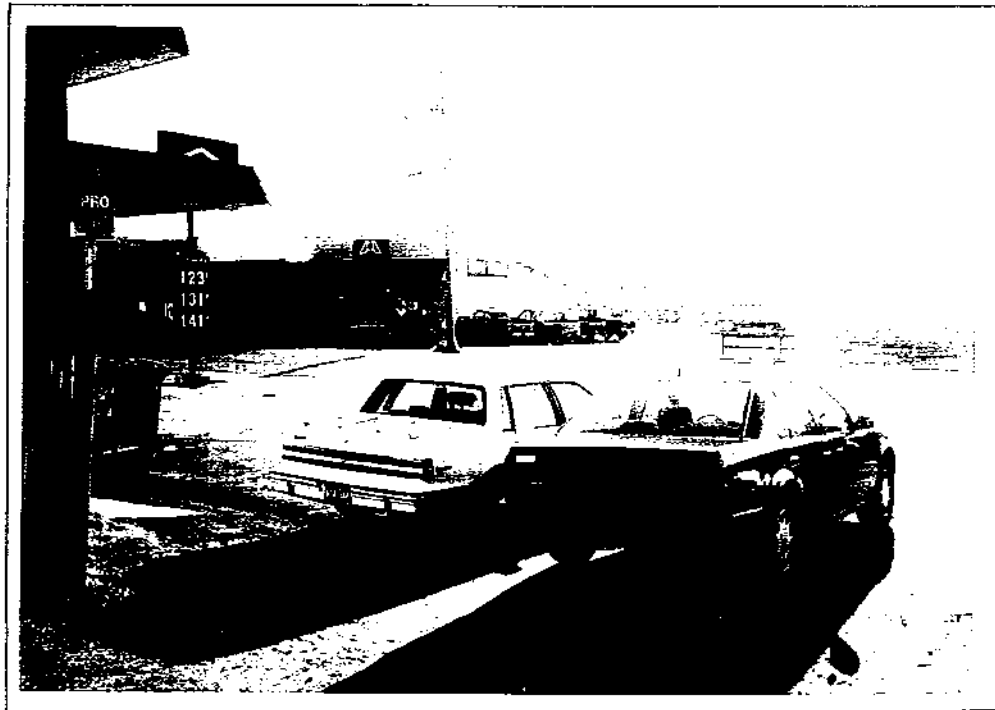
VIEW FROM MW-6 TOWARD SOUTHWEST
(Caledonia Auto Parts Downgradient of Site)

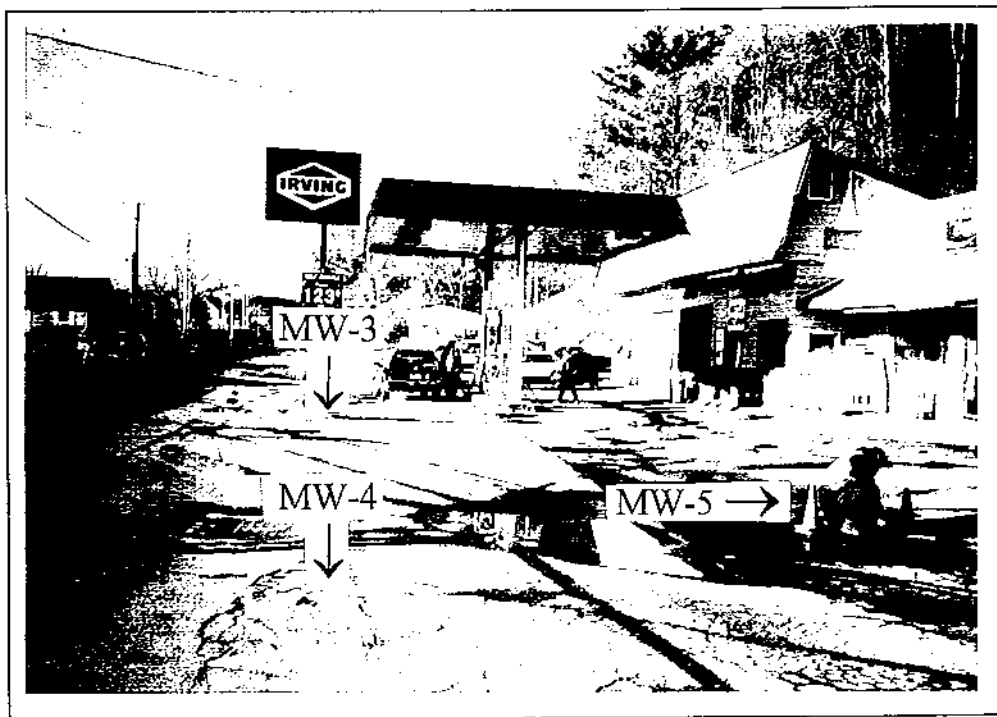
VIEW TOWARD NORTH
(Location of MW-3, MW-4 and MW-5)

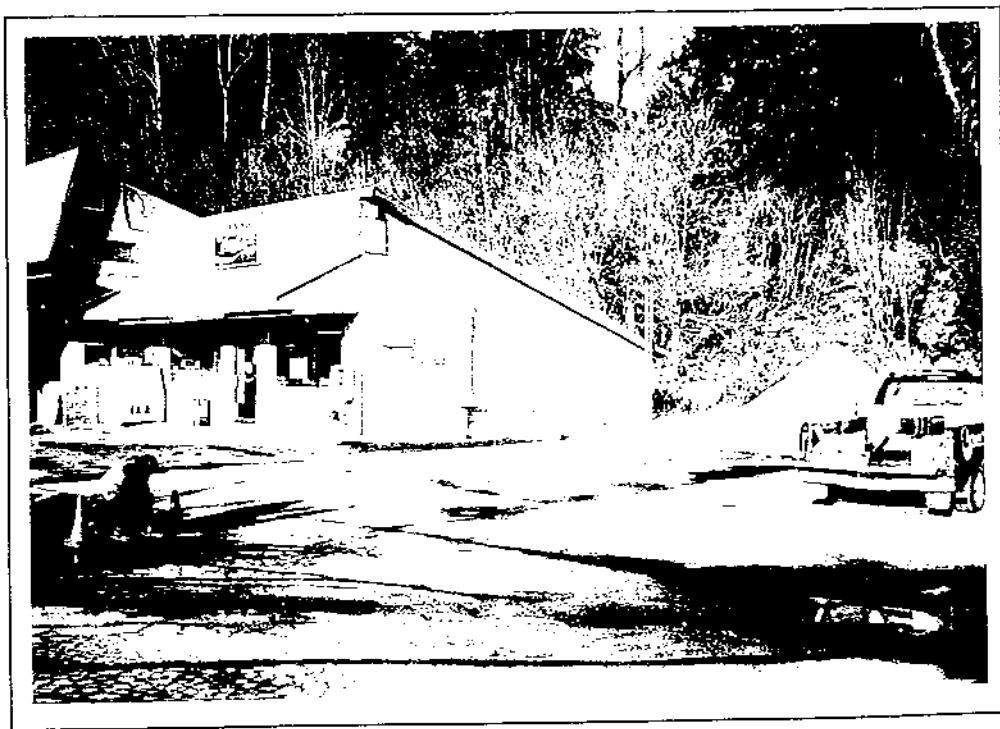
VIEW TOWARD NORTHEAST
(Field Scientist at MW-5)

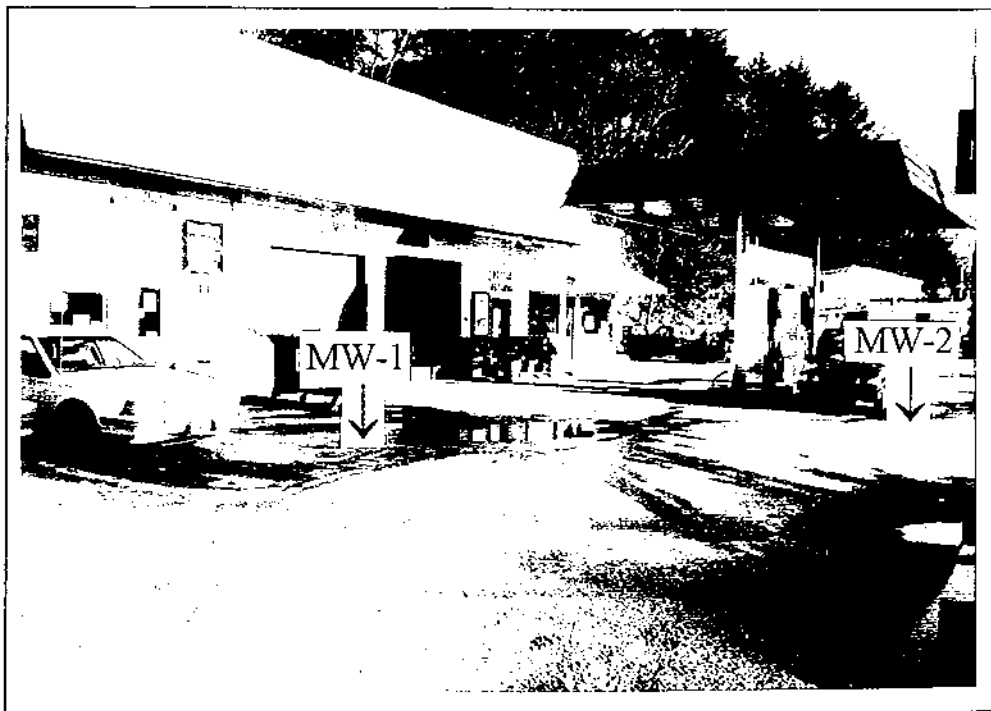
VIEW TOWARD SOUTHWEST
(MW-1 and MW-2)
